Lorna Well 1 and 2 Assessment and Repair Report
(February 2012)

Reference: Sault Ste. Marie Well Assessment and Repair
Lorna Ave. Wells No. 1 and No. 2

Lorna Well 1 and 2 Assessment and Repair Report
(June 2012)

Reference: Sault Ste Marie Well Assessment and Repair
Lorna Well No. 1 and No. 2

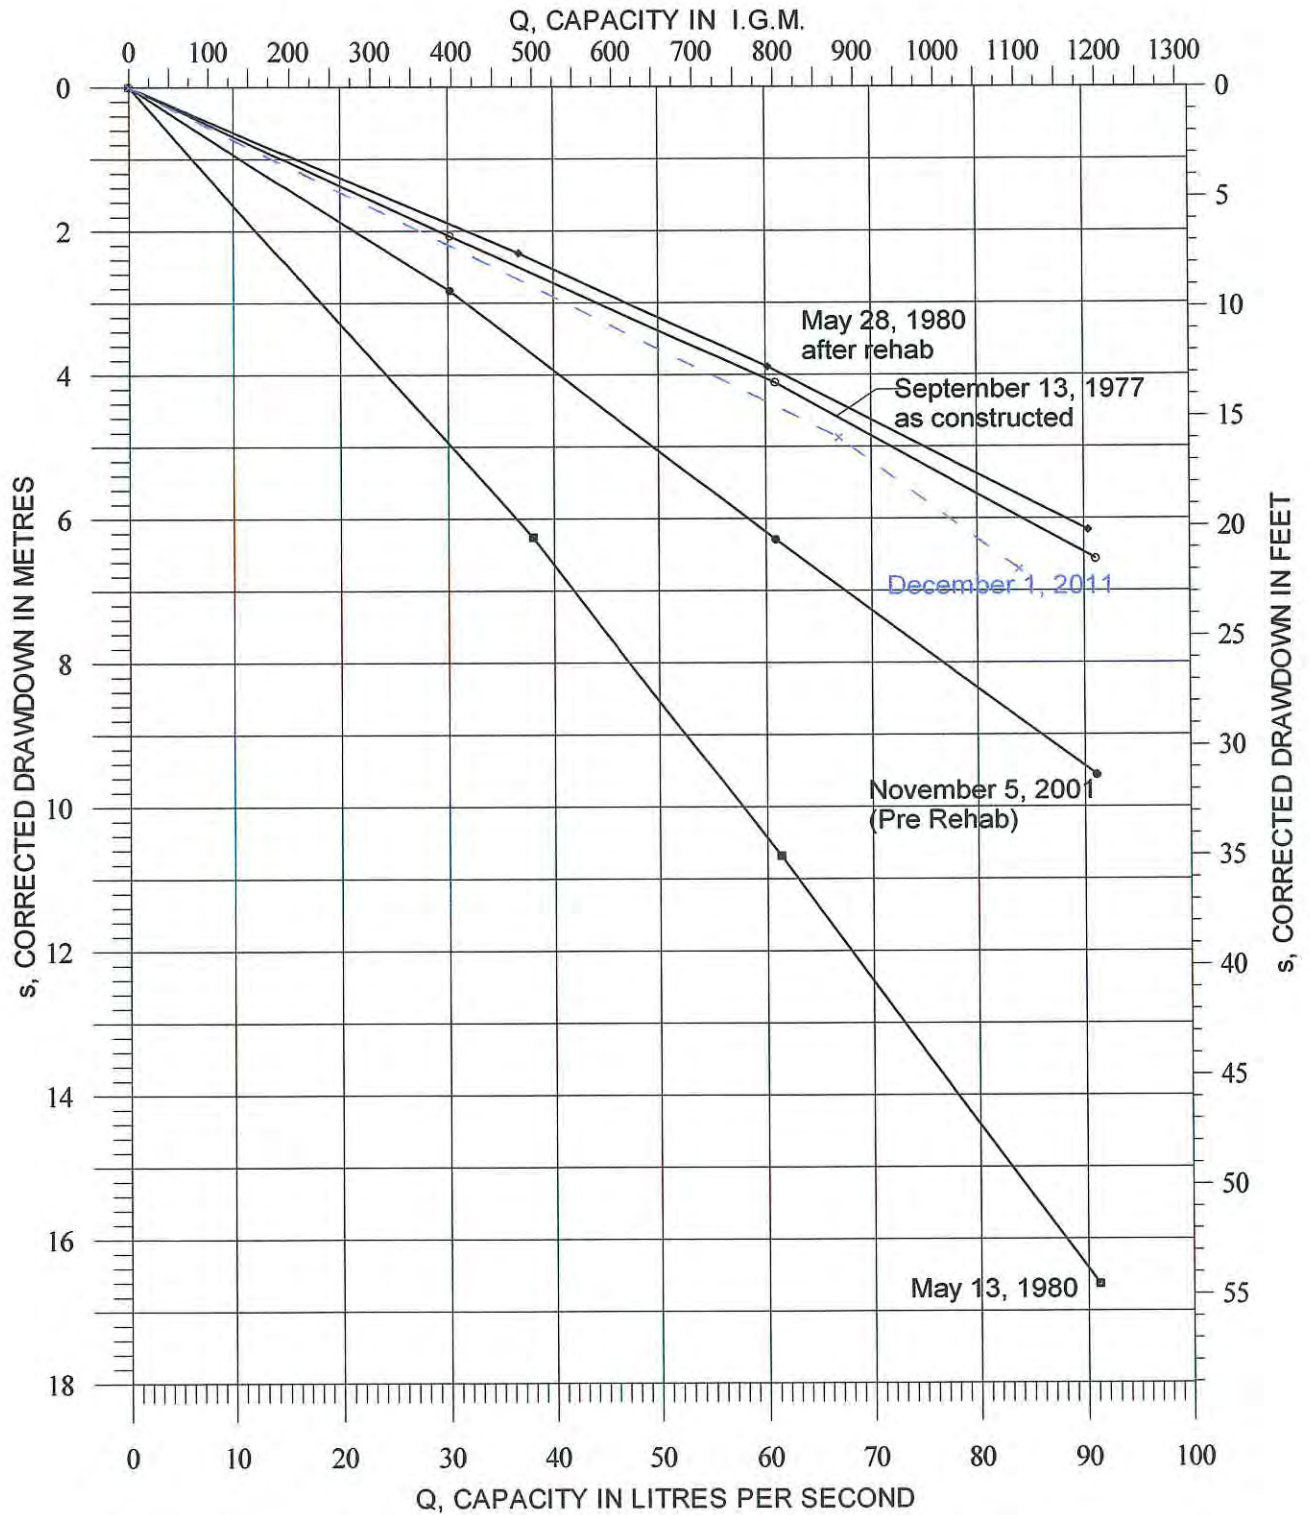
Dwg. No. L12033

The results of the well performance test are plotted on the attached Drawdown vs Capacity graph. For comparison, the results of previous testing; after construction in 1977, and tests following the 1980 and 2001 rehabilitation treatments are also shown. The results indicate that well performance has only slightly deteriorated since last testing in 2001.

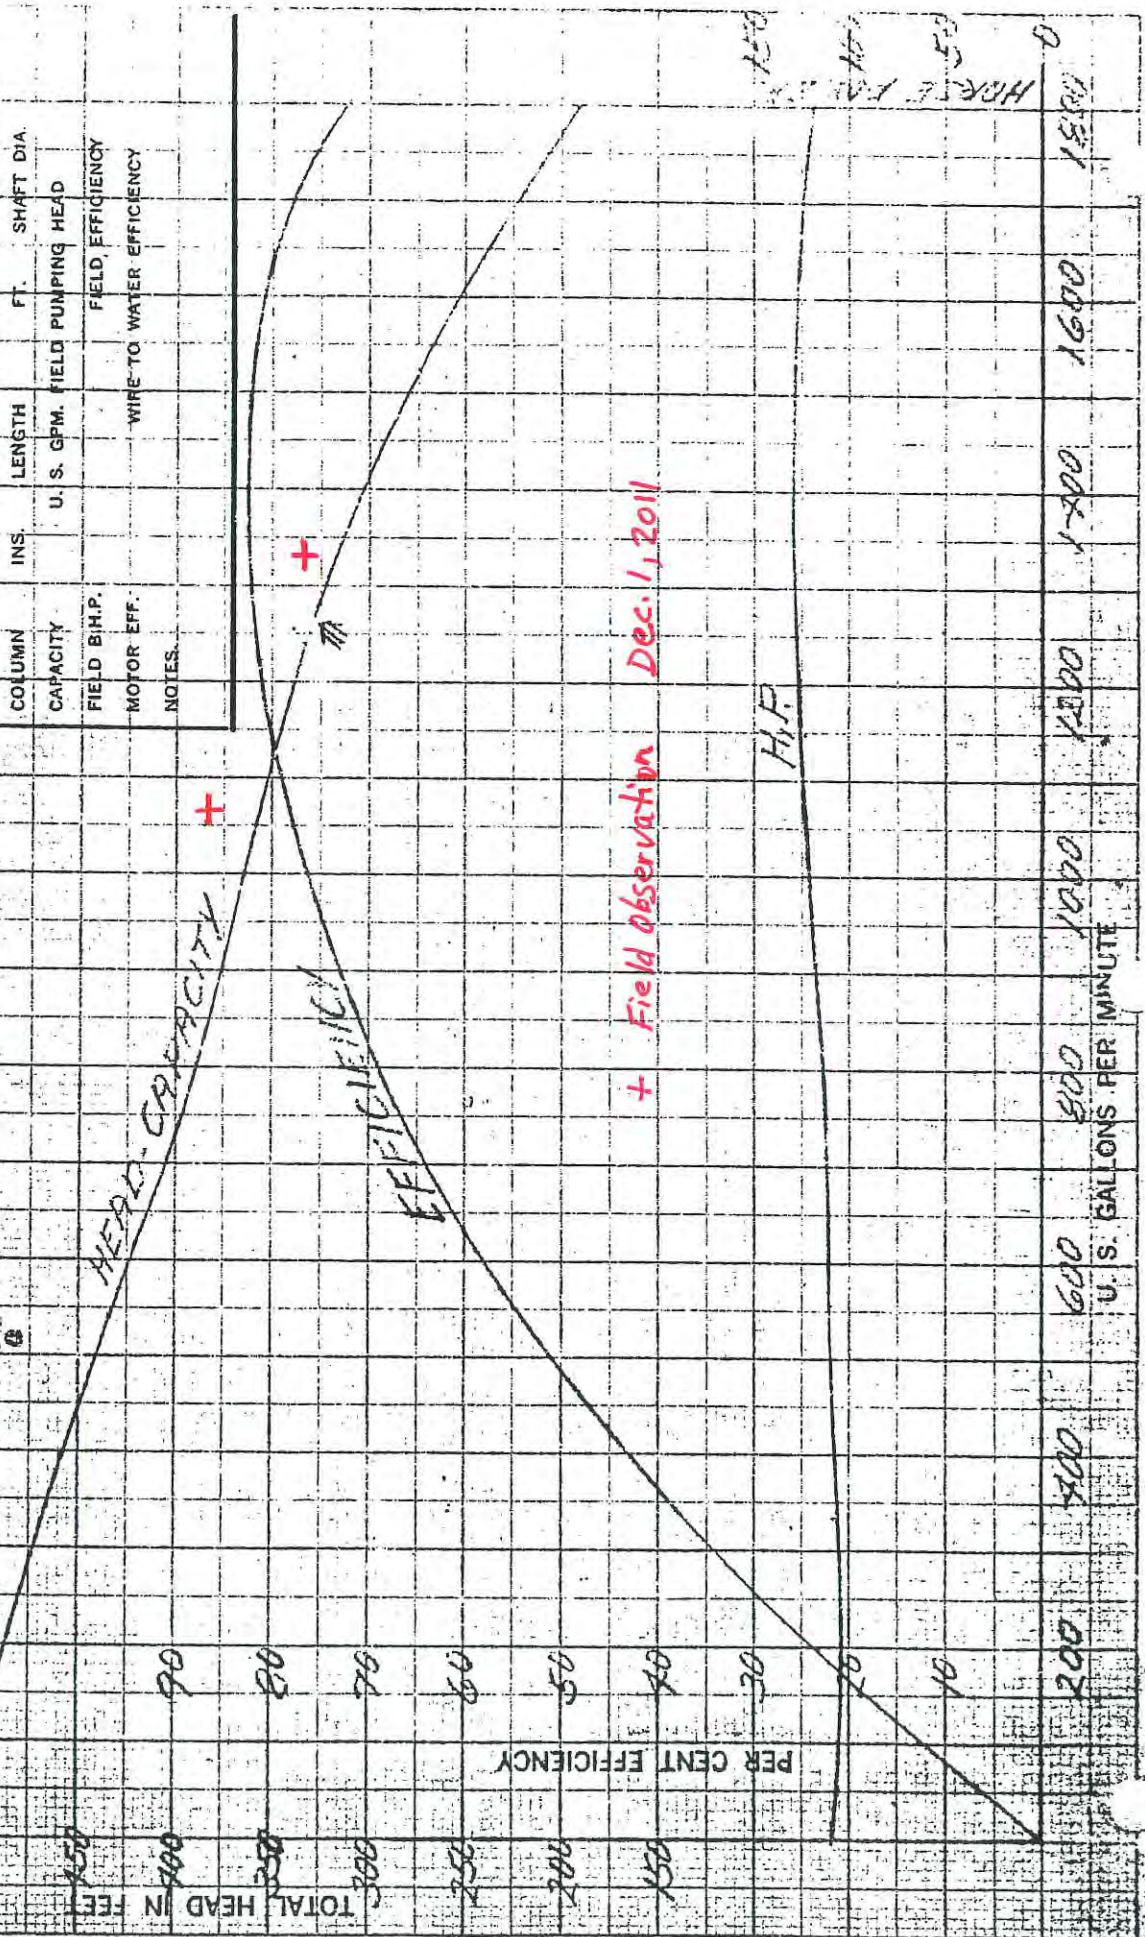
DEEP WELL TURBINE PUMP PERFORMANCE CHART

Pump performance was observed to be near to, and slightly high when compared to the factory curve.

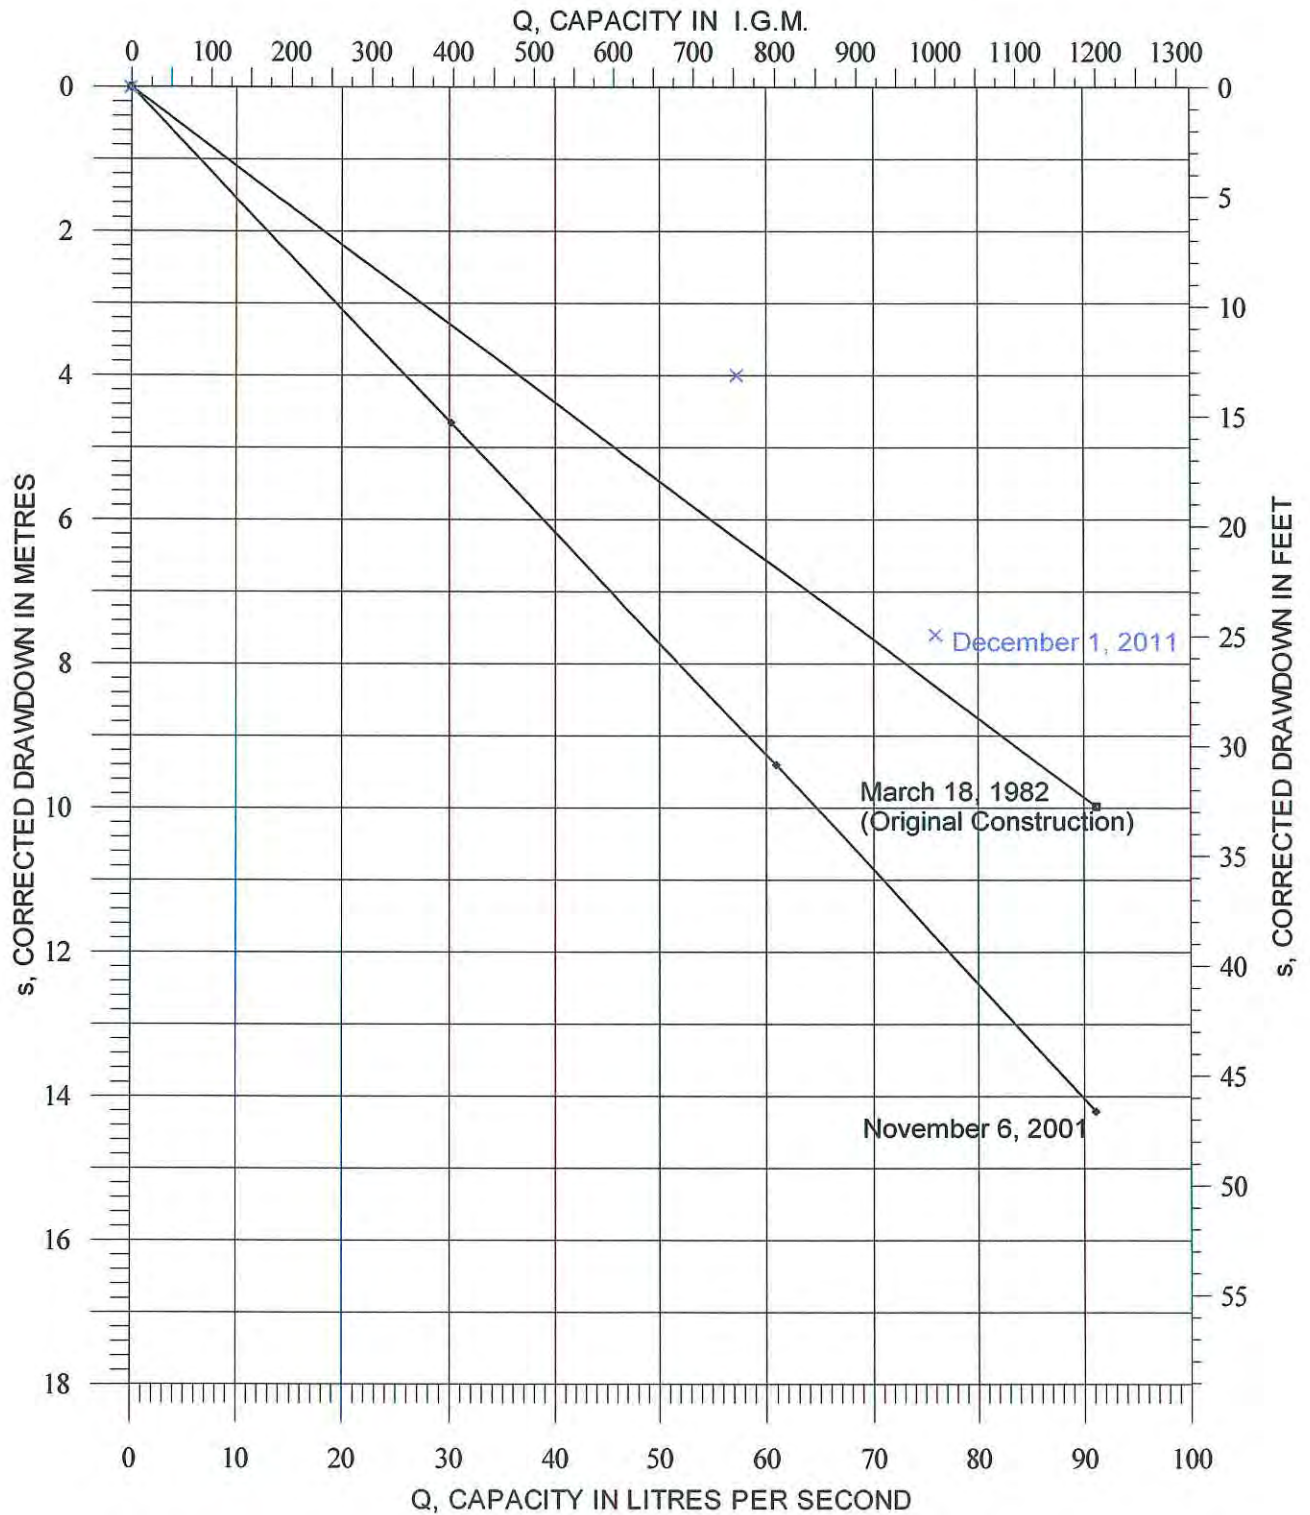
Dwg. No. L12033

The results of the well performance test are plotted on the attached Drawdown vs Capacity graph. For comparison, the results of previous testing; after construction in 1982 and in 2001 are also shown. These results indicate that performance appears to be improved compared to original. Although approximately 5 ft of screen has been filled with cement grout, rehabilitation efforts by others to remove cement from the well appear to have improved overall well performance.

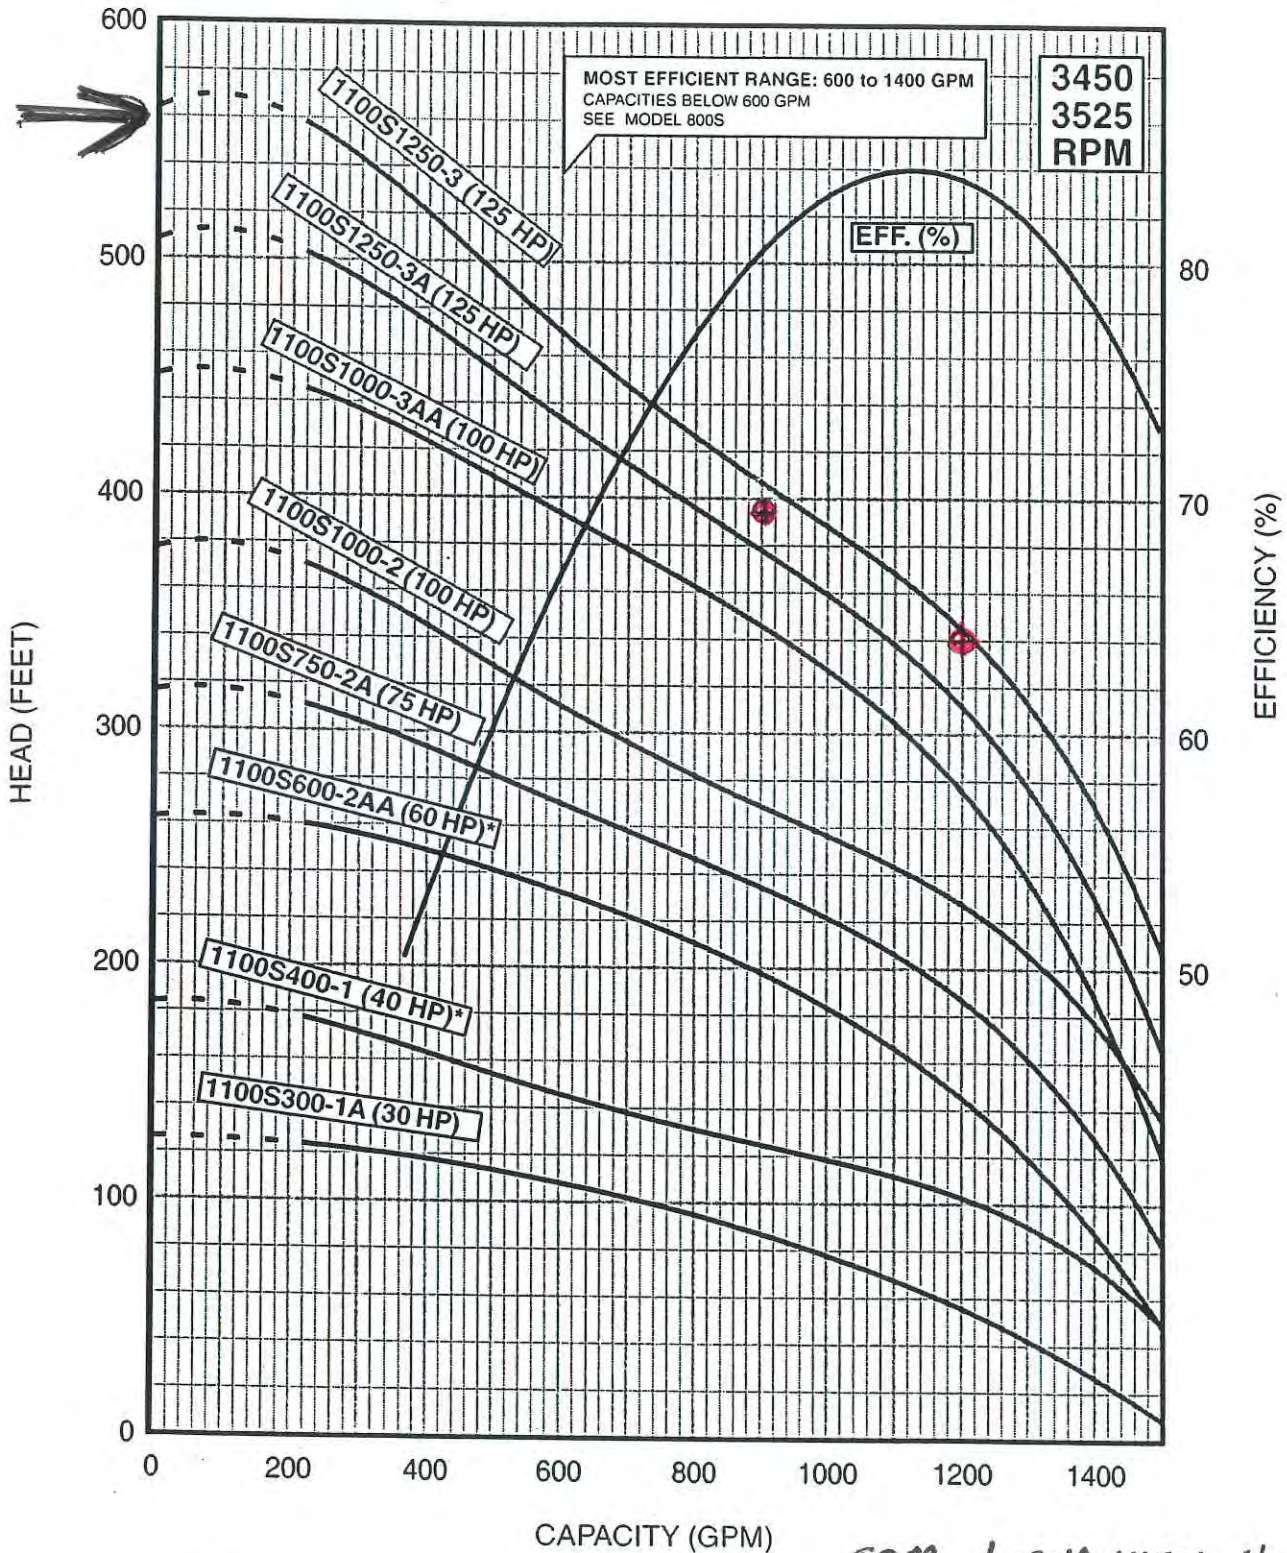
Performance Curves

Pump performance was observed to be near to, and slightly low, when compared to the factory curve.

⊕ Field observed Dec 1, 2011
