**Steelton Municipal Well Preliminary Inspection and Testing**  
**(November 2013)**

Reference: Steelton Well PW1  
Preliminary Inspection and Testing

We have completed our preliminary inspection and testing of the Steelton Well PW1 and review of information provided for Well 6.

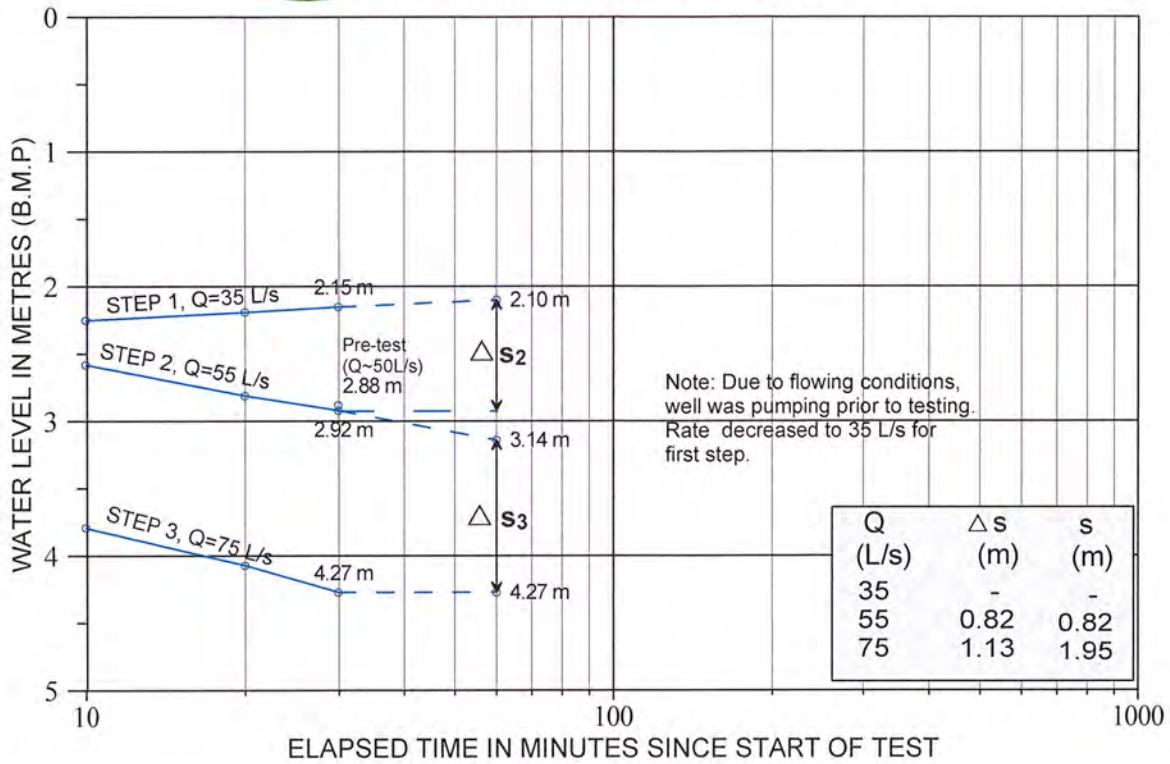
**October 7, 2013**

We were unable to shut down PW1 and operate Well 6 to establish a measurable “static” water level prior to performance testing. A stepped rate test was conducted on Oct 7, 2013. PW1 was already operating @ 35 L/s. The rate was increased to 55 L/s and then 75 L/s for 30 minutes each. A plot of the test data is shown on A13018 (Draft). Due to the flowing artesian conditions at this site, it is difficult to accurately determine well performance

During the test, the Goulais site was reportedly operating at 3000 m<sup>3</sup>/day (35 L/s). . Previous reporting indicates that the operation of Goulais at 114 L/s (1500 IGM) causes a 10m (33ft) interference at Steelton. Thus during the testing on Oct 7 we expect that there is approximately 3m (10 ft) of interference during the test.

If a conservative estimate of the historic static water level of + 6m (20 ft) is used then the net drawdown for the rates of 35, 55, 75 L/s would be in the order of 5.2, 6.4 and 7.3 m. These are plotted on the attached Specific Capacity drawing A13109 (Draft)

Well performance appears to be somewhat improved compared to historic production. No well performance rehabilitation is necessary to improve well performance.

Once the pump is reinstalled in PW1, we would recommend continuing to operate Well 6 at a reduced capacity in order to further assess PW1 specific capacity during start up.
