**Lorna Well 1 and 2 Assessment and Repair Report
(February 2012)**

Reference: Sault Ste. Marie Well Assessment and Repair
Lorna Ave. Wells No. 1 and No. 2

**Lorna Well 1 and 2 Assessment and Repair Report
(June 2012)**

Reference: Sault Ste Marie Well Assessment and Repair
Lorna Well No. 1 and No. 2

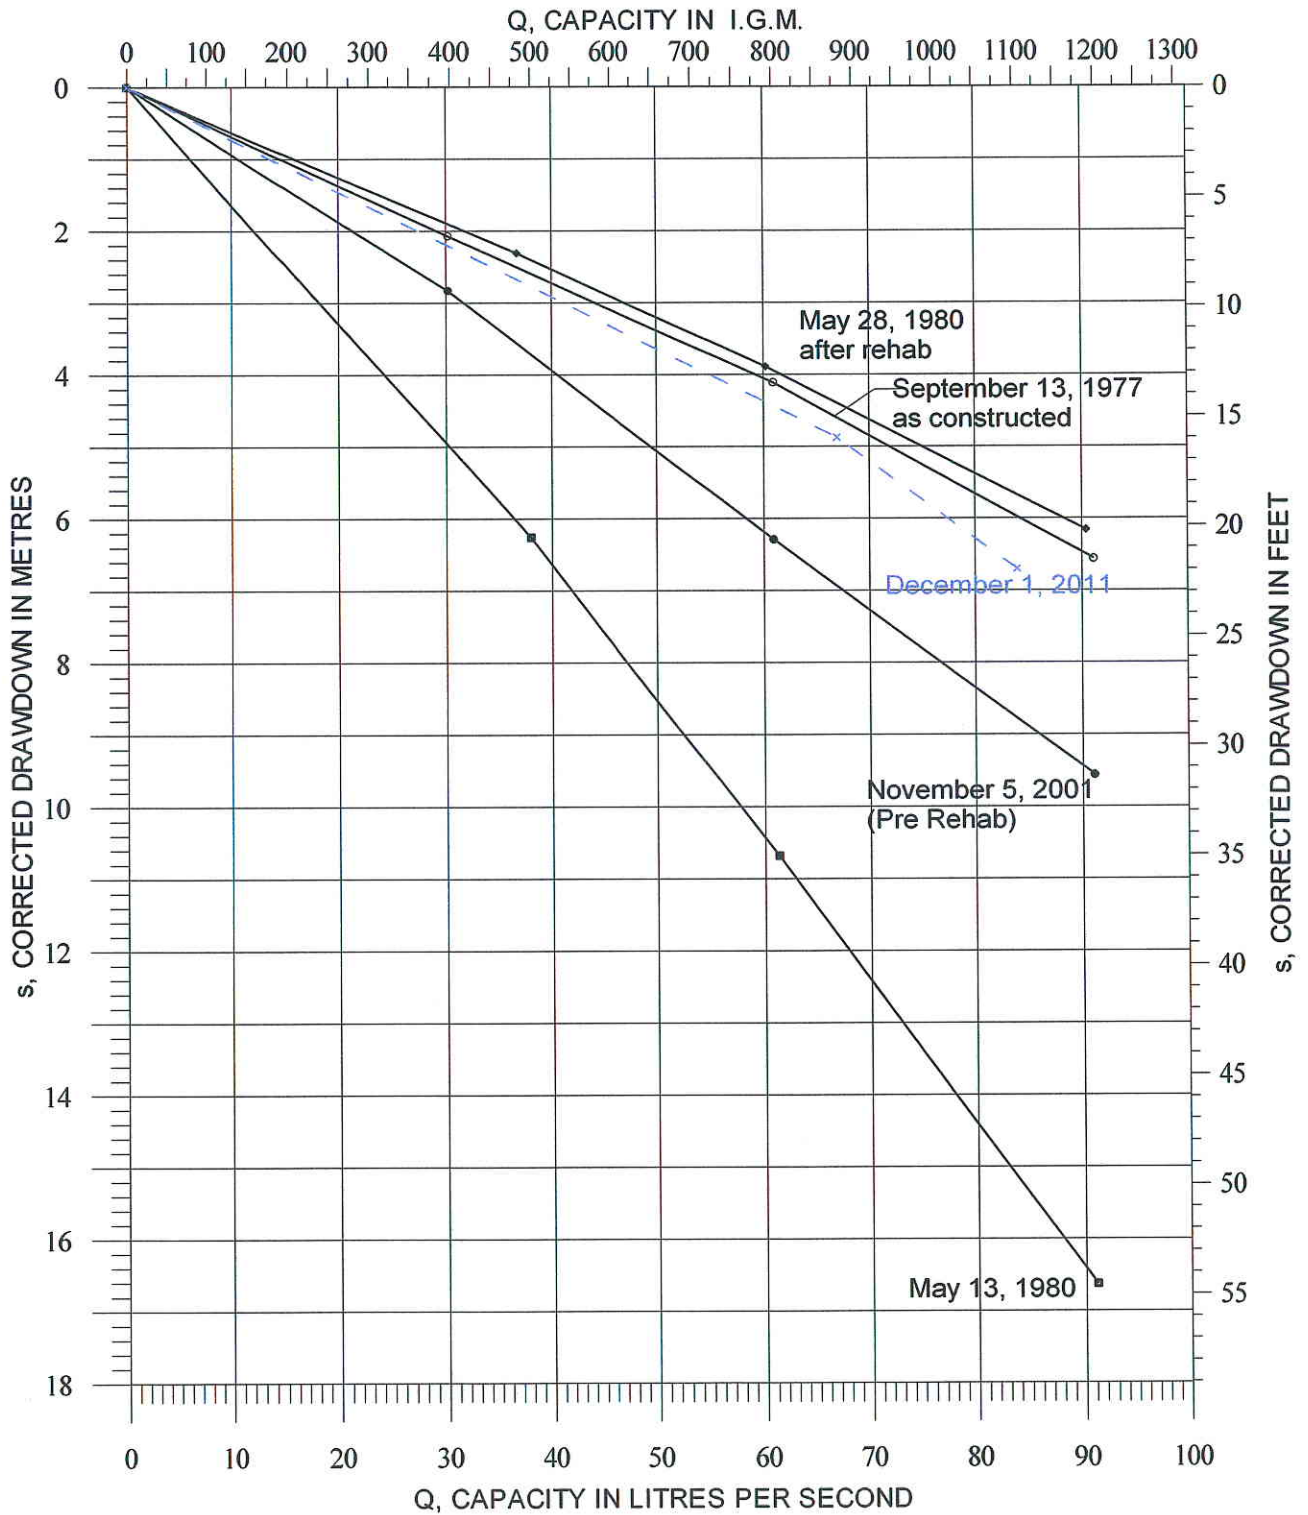
Dwg. No. L12033

The results of the well performance test are plotted on the attached Drawdown vs Capacity graph. For comparison, the results of previous testing; after construction in 1977, and tests following the 1980 and 2001 rehabilitation treatments are also shown. The results indicate that well performance has only slightly deteriorated since last testing in 2001.

1. Current Well performance at Lorna Well No. 1 is considered satisfactory compared to previous testing. No well maintenance rehabilitation work is required. The accumulated soft debris and two pieces of steel bar at the bottom of the well could be removed at this service interval.
2. Regular recordings of production, water levels and above ground level should be maintained in order to monitor any changes in well or pump performance. A Well and Pump performance test should be conducted every 5 years.
3. Pump performance follows near to the factory curve. On disassembly and inspection the bowl was found to be in generally good condition. It requires replacement of standard wearing parts.

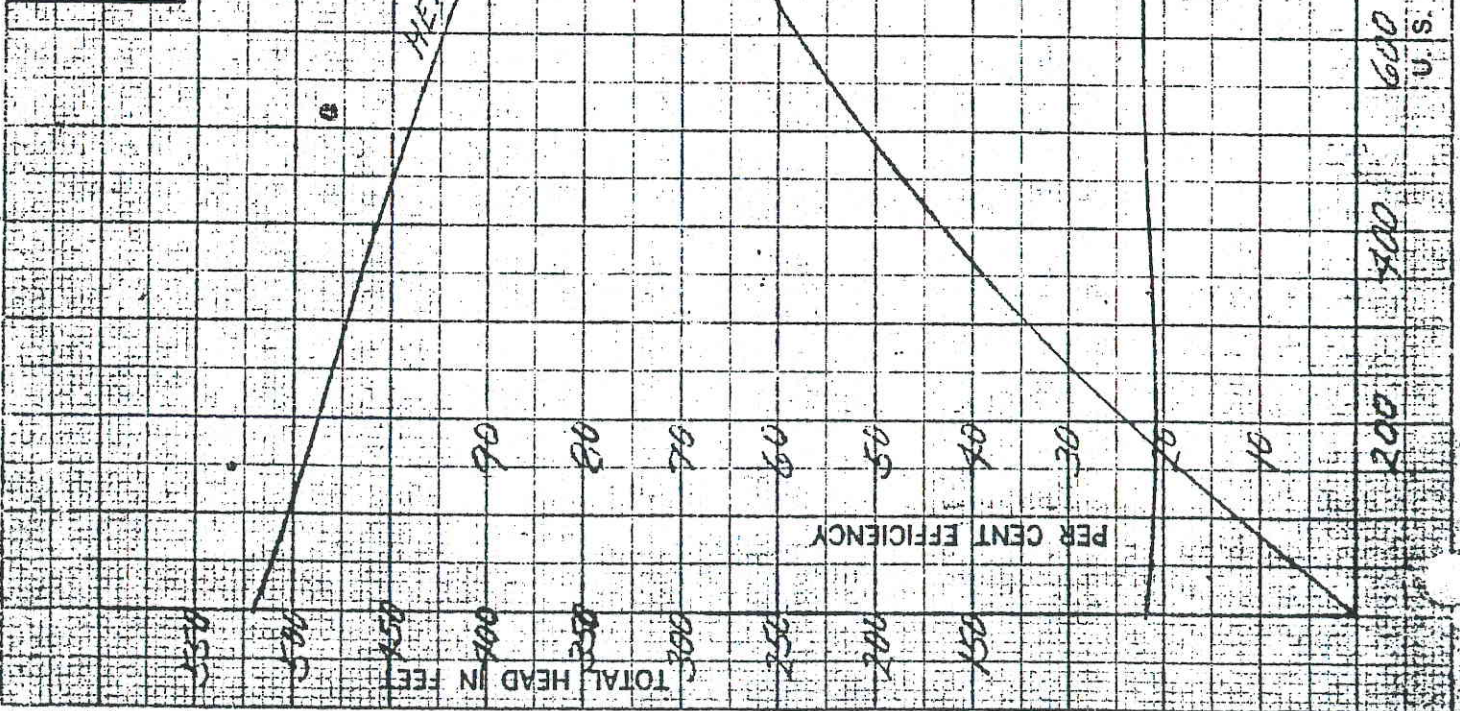
Pump performance was observed to be near to, and slightly high when compared to the factory curve.

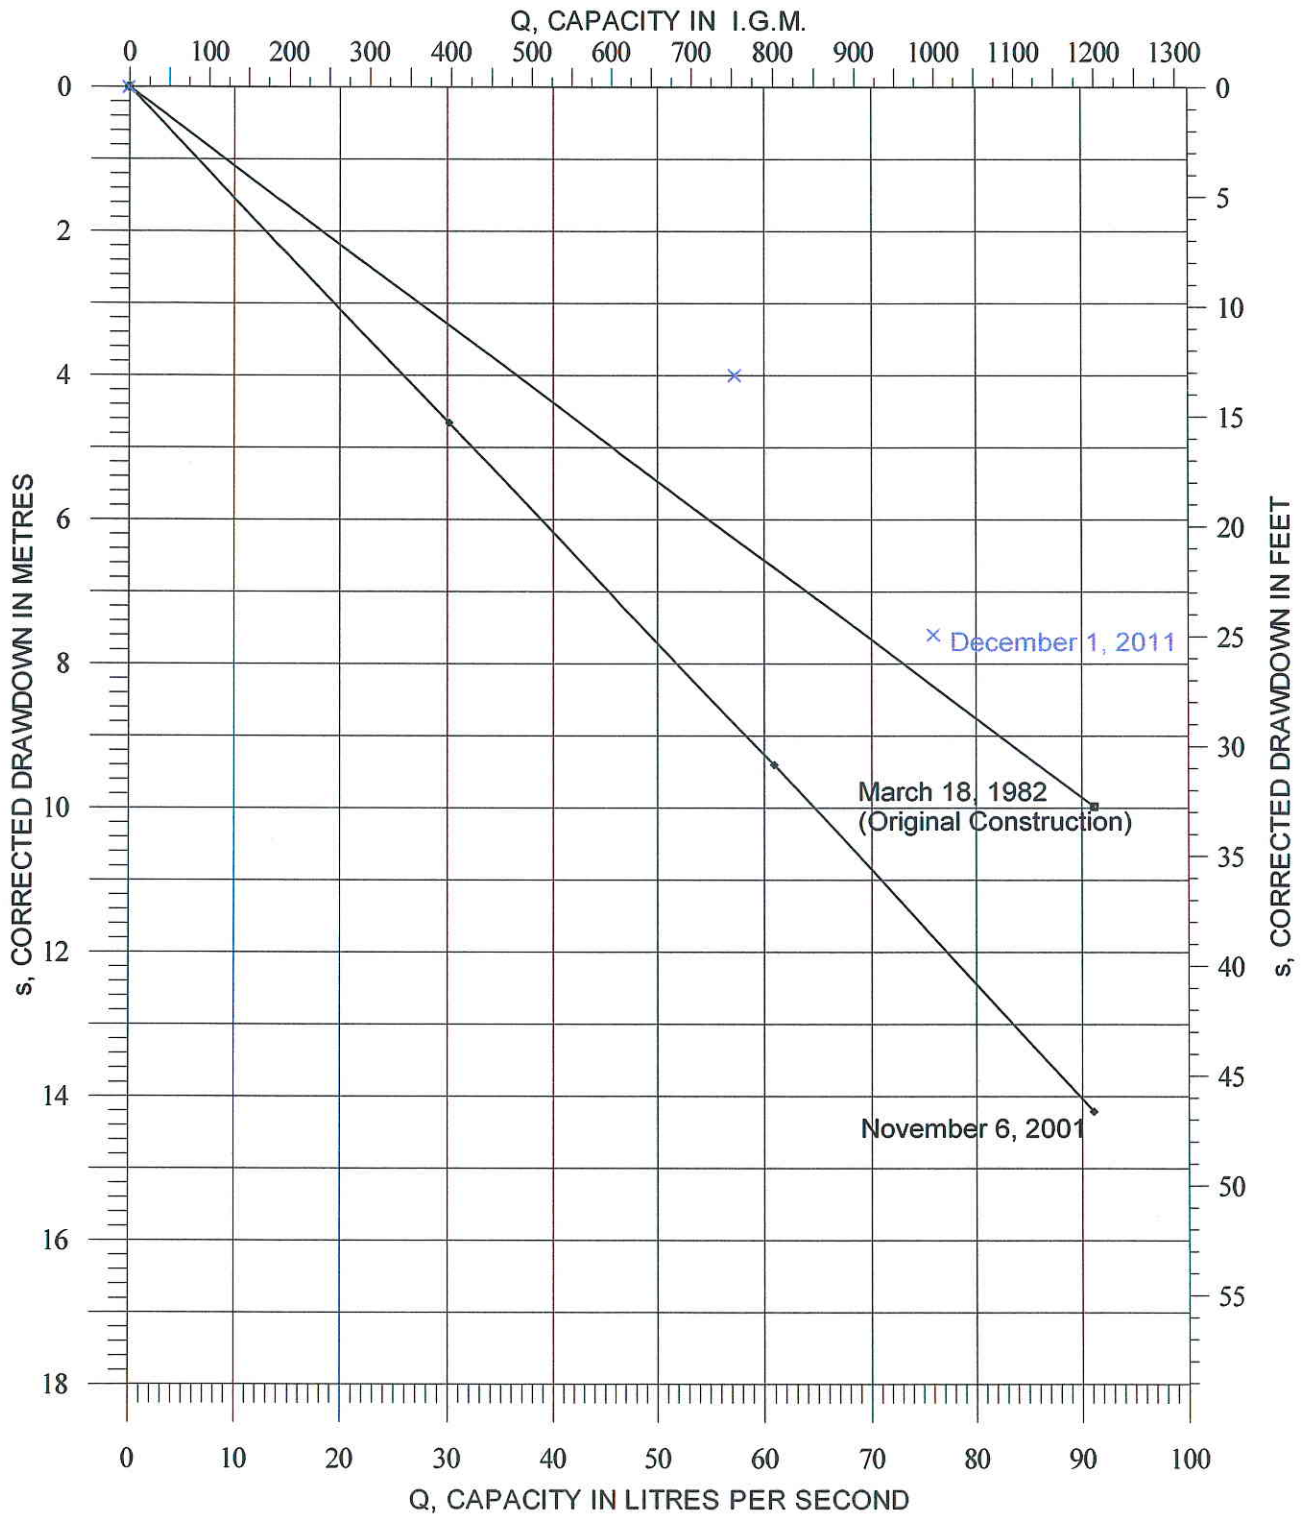
Dwg. No. L12033

The results of the well performance test are plotted on the attached Drawdown vs Capacity graph. For comparison, the results of previous testing; after construction in 1982 and in 2001 are also shown. These results indicate that performance appears to be improved compared to original. Although approximately 5 ft of screen has been filled with cement grout, rehabilitation efforts by others to remove cement from the well appear to have improved overall well performance.

1. Current Well performance at Lorna Well No. 2 is considered good compared to the historic reported testing. Well performance appears to be near to and slightly improved compared to performance tests following construction in 1982. No well maintenance rehabilitation work is required at this time. The accumulated soft debris with the bottom of the well could be removed at this service interval.
2. Regular recording of production, water levels, and above ground head should be maintained in order to monitor any changes in well or pump performance.

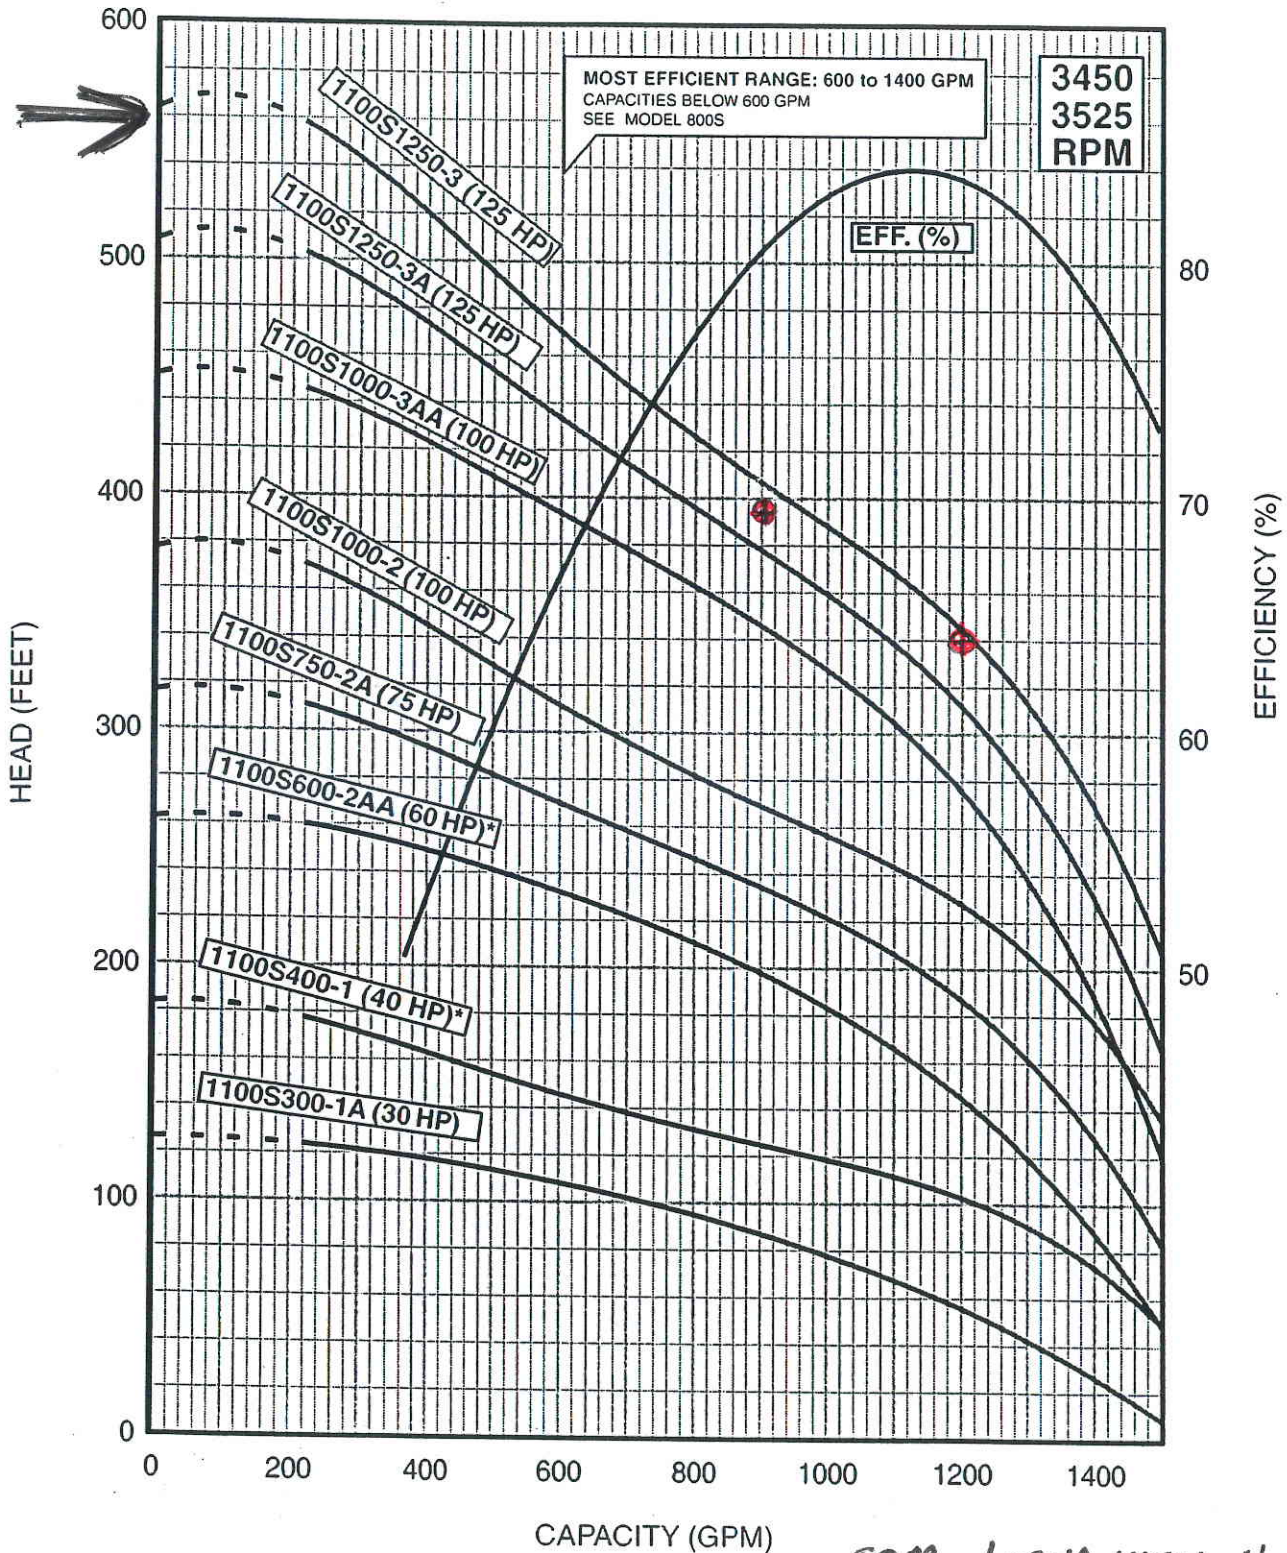
⊕ Field observed Dec 1, 2011

Pump performance was observed to be near to, and slightly low, when compared to the factory curve.

3. Pump performance follows near to, but slightly lower when compared to the factory performance curve.
