Steelton Municipal Well Preliminary Inspection and Testing
(November 2013)

Reference: Steelton Well PW1
Preliminary Inspection and Testing

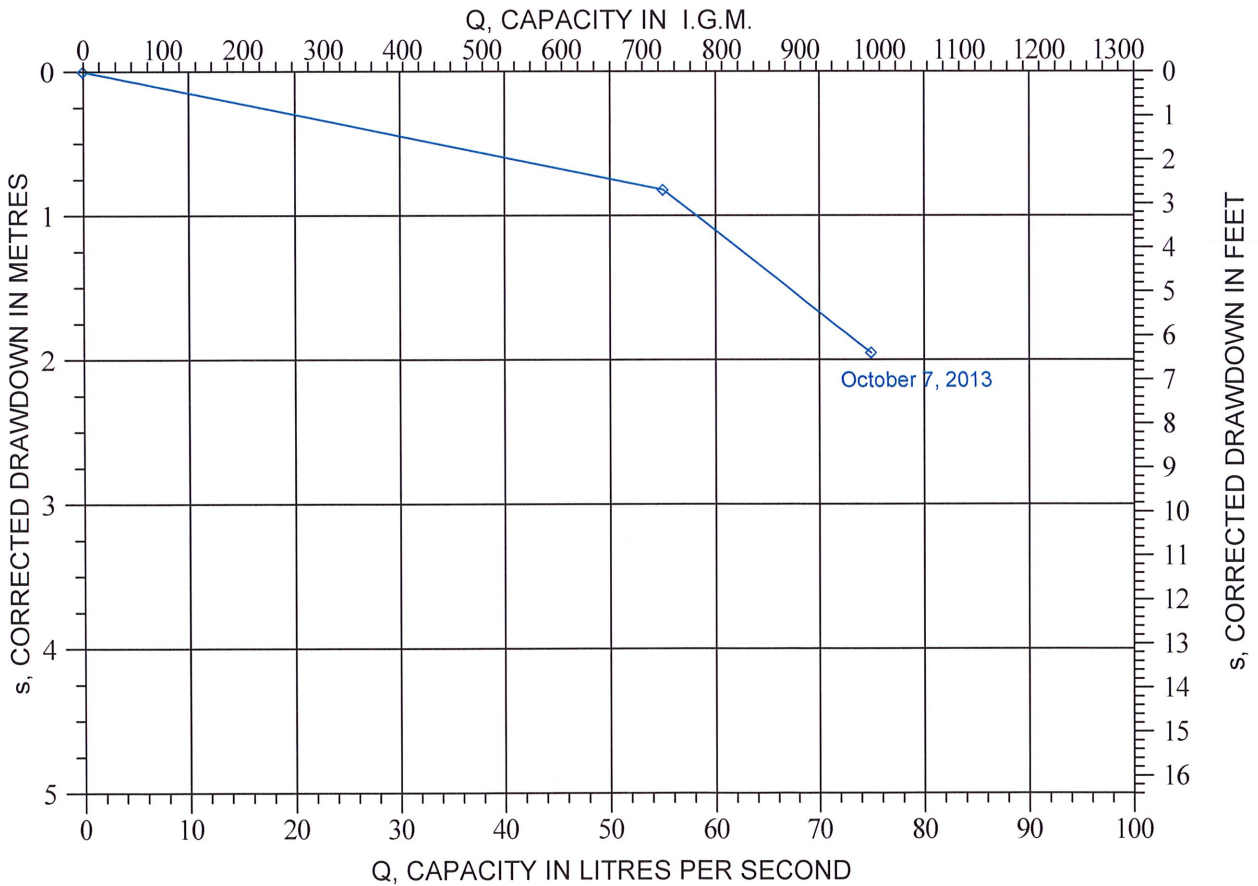
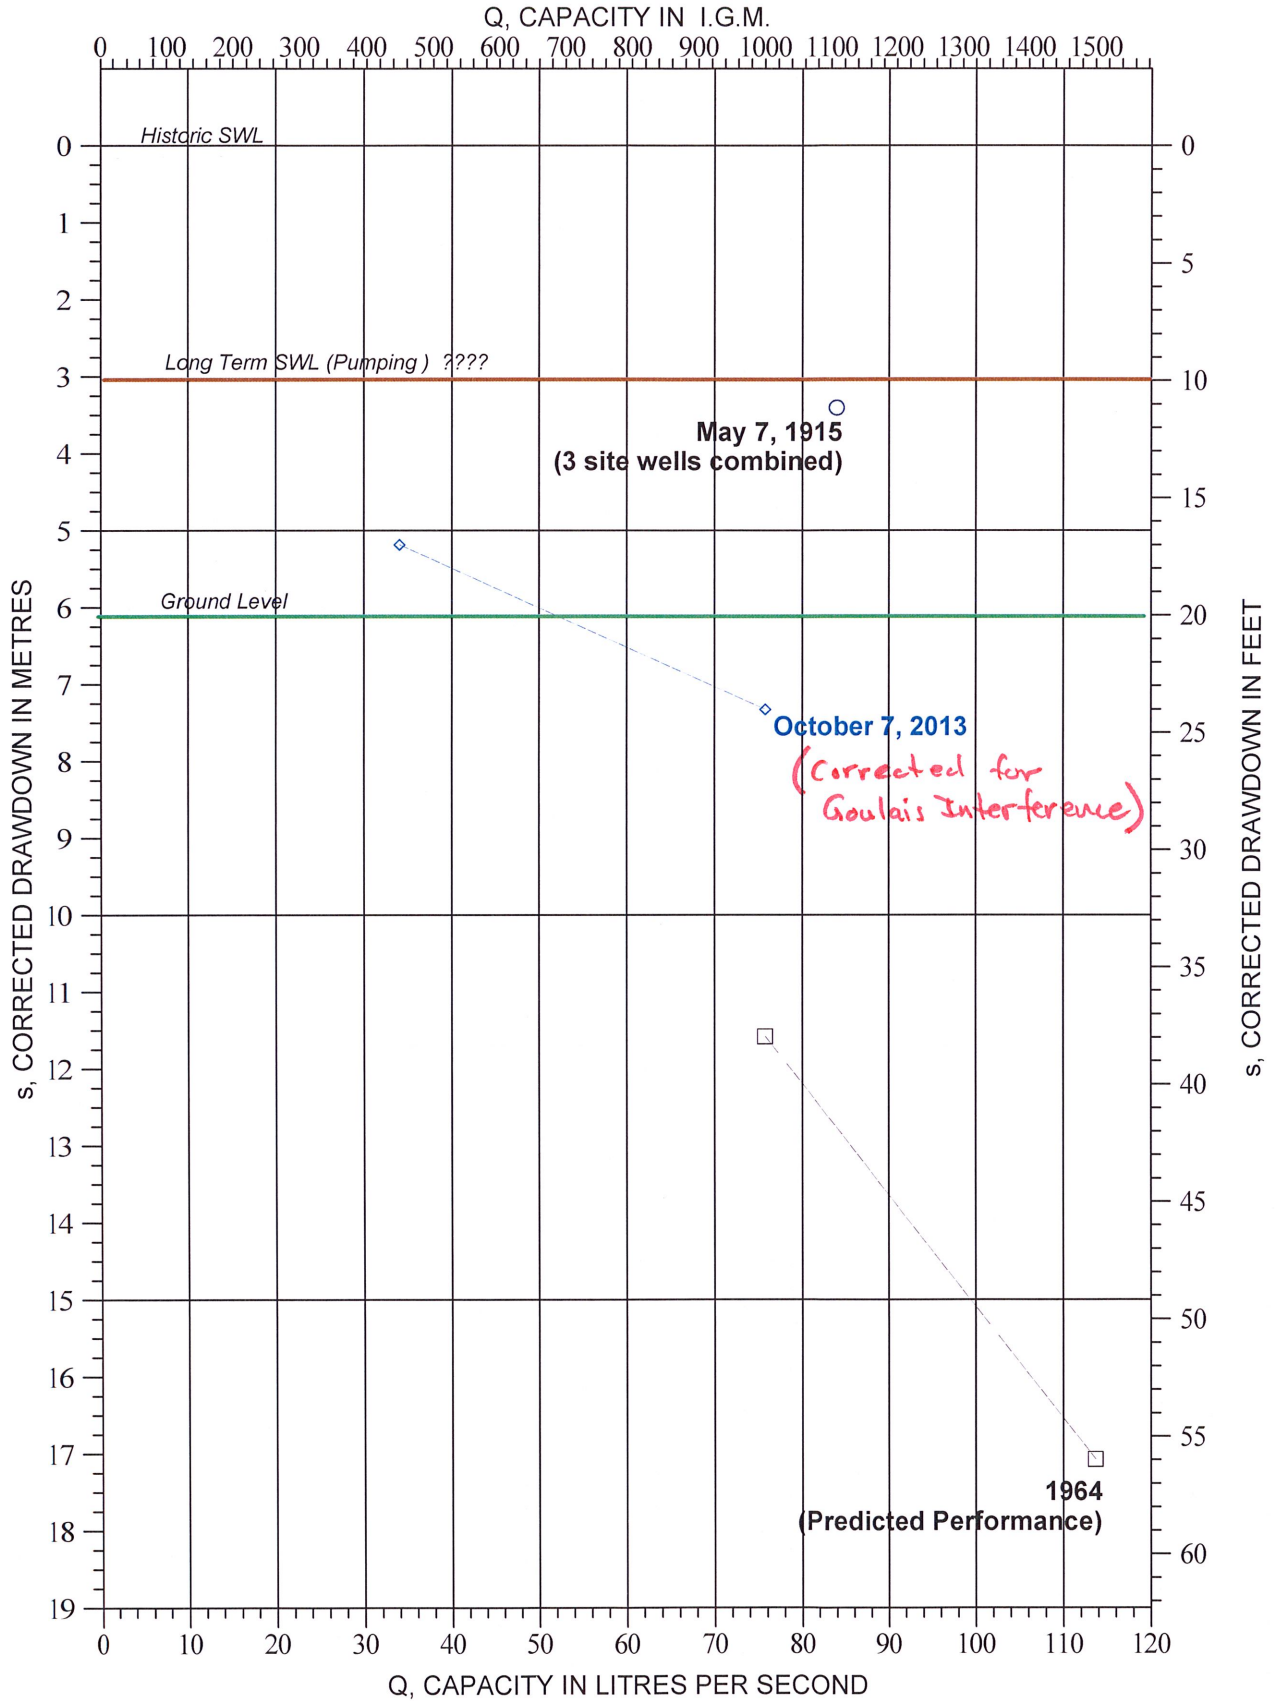
STEELTON WELL
WELL PERFORMANCE
Dwg. No. A13108

We were unable to shut down PW1 and operate Well 6 to establish a measurable “static” water level prior to performance testing. A stepped rate test was conducted on Oct 7, 2013. PW1 was already operating @ 35 L/s. The rate was increased to 55 L/s and then 75 L/s for 30 minutes each. A plot of the test data is shown on A13018 (Draft). Due to the flowing artesian conditions at this site, it is difficult to accurately determine well performance

During the test, the Goulais site was reportedly operating at 3000 m³/day (35 L/s). . Previous reporting indicates that the operation of Goulais at 114 L/s (1500 IGM) causes a 10m (33ft) interference at Steelton. Thus during the testing on Oct 7 we expect that there is approximately 3m (10 ft) of interference during the test.

If a conservative estimate of the historic static water level of + 6m (20 ft) is used then the net drawdown for the rates of 35, 55, 75 L/s would be in the order of 5.2, 6.4 and 7.3 m. These are plotted on the attached Specific Capacity drawing A13109 (Draft)

Well performance appears to be somewhat improved compared to historic production. No well performance rehabilitation is necessary to improve well performance.

Once the pump is reinstalled in PW1, we would recommend continuing to operate Well 6 at a reduced capacity in order to further assess PW1 specific capacity during start up.
