**Steelton Municipal Well Preliminary Inspection and Testing**  
**(November 2013)**

Reference: Steelton Well PW1  
Preliminary Inspection and Testing

We have completed our preliminary inspection and testing of the Steelton Well PW1 and review of information provided for Well 6.

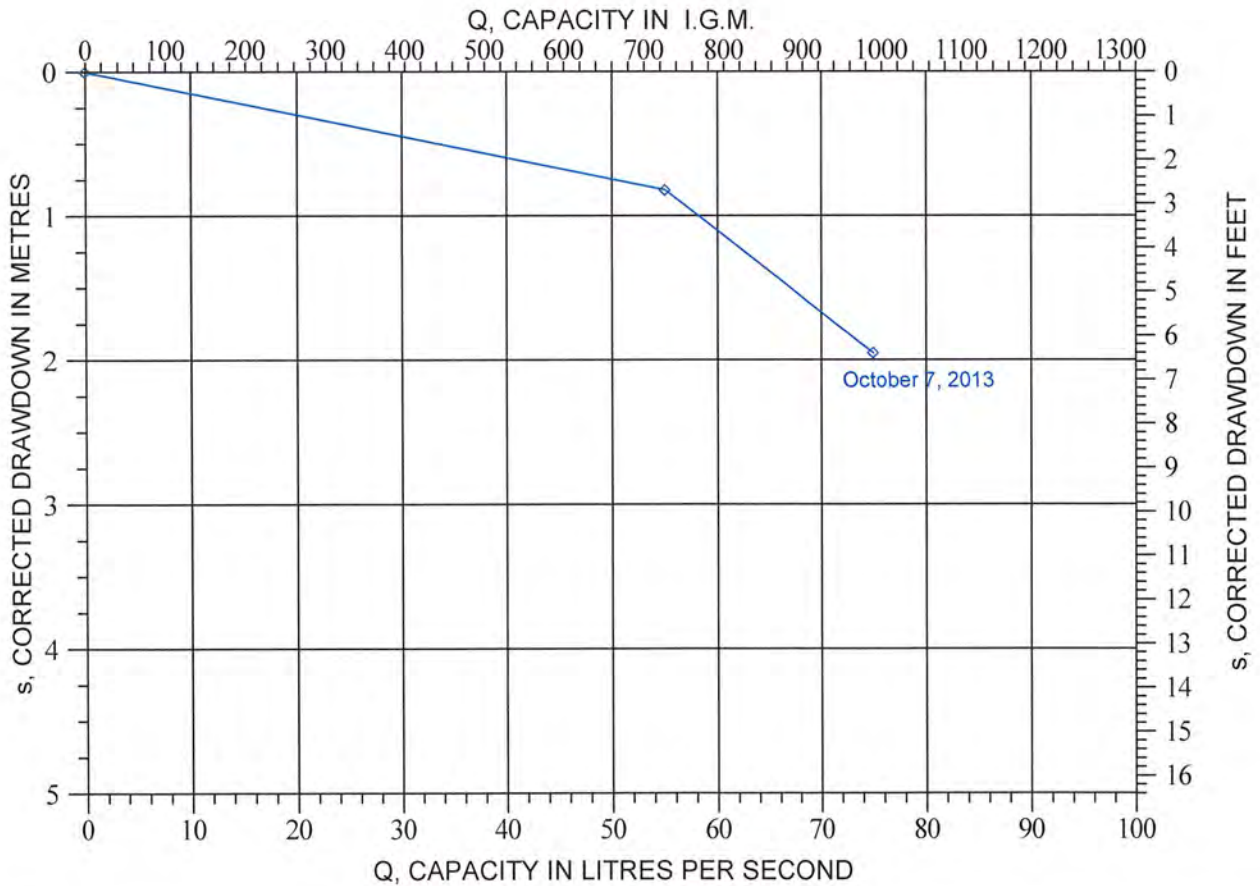
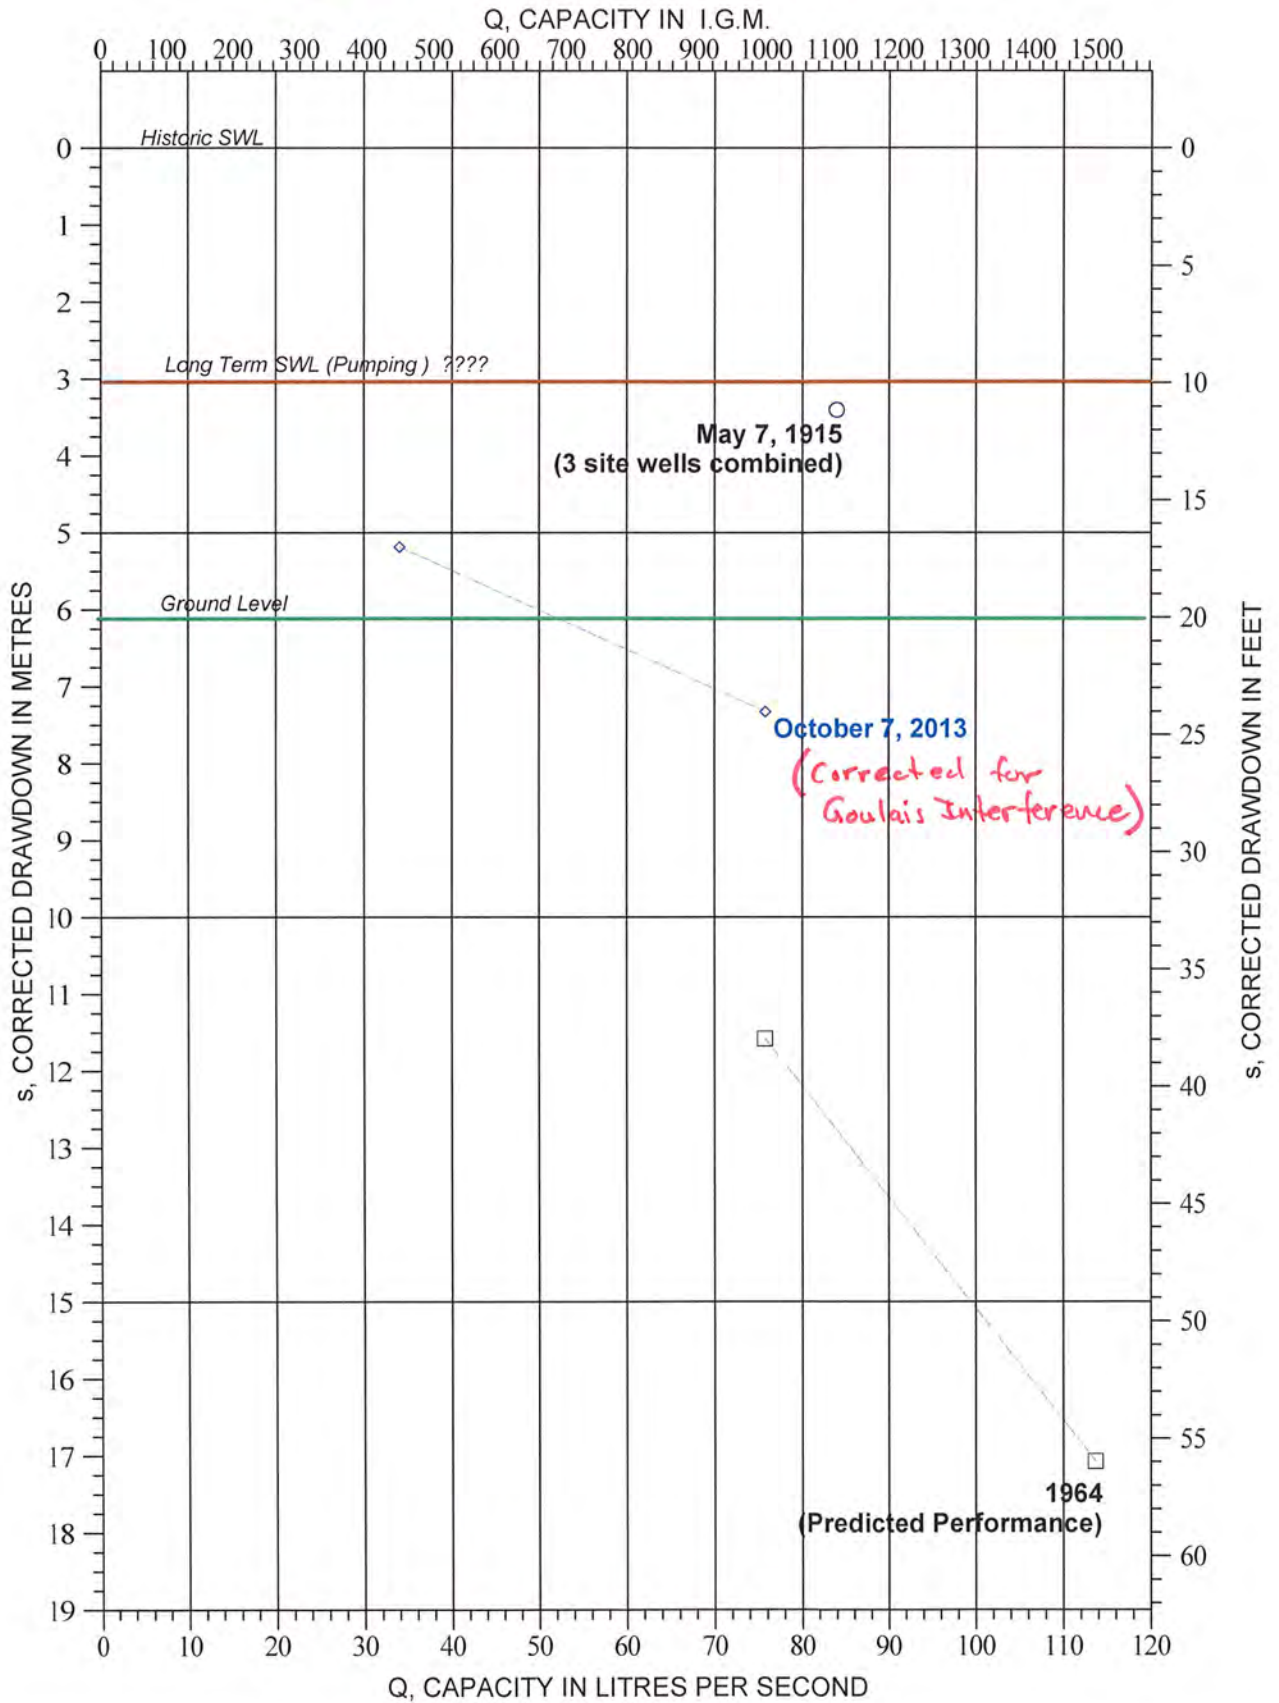
**October 7, 2013**

The current video inspection showed no obvious structural concerns with the well. Comparison of the video was made to that of previous inspections by IWS in 1969 and 1993. Very similar conditions are noted and there are no apparent changes. Attached are several captured images from 1969 and 1993.

The current video shows that the well condition has not materially changed since 1969. A cavity in the sandstone is not observed. The louvered screen section in the well is plugged with mineral deposits and has not contributed water for over 40+ years. Well performance appears unaffected.
